Company Name: **Leopalace21 Corporation**
Representative: Eisei Miyama, President and CEO
Code Number: 8848 (Tokyo Stock Exchange, First Section)
Contact: Bunya Miyao, Director
Tel: +81-50-2016-2907
E-mail: ir@leopalace21.com

**Notice Regarding Non-compliance with Specifications Approved
Based on Building Standards Act**

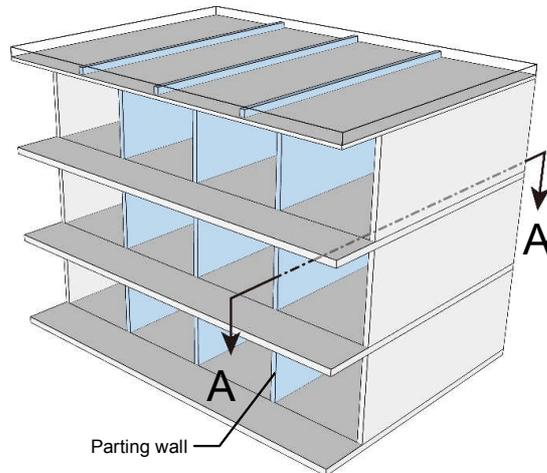
Position of parting wall

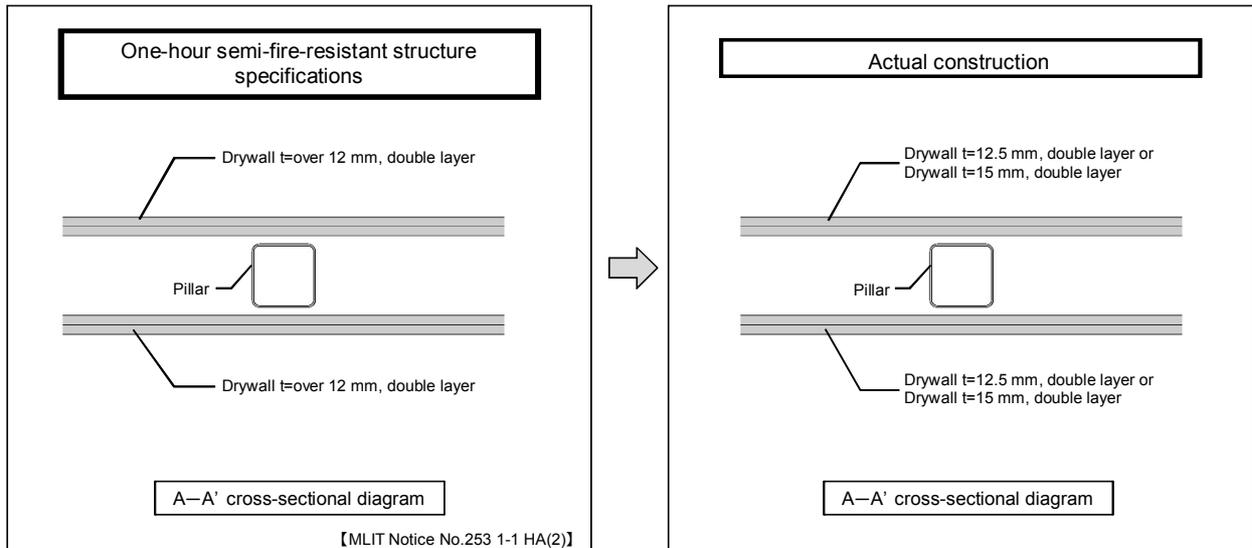
[Figure 1]

We believe 62 out of the 63 buildings comply with 2015 Ministry of Land, Infrastructure and Transport Notice No. 253 (appendix 2 figure 1) which meet one-hour semi-fire-resistant performance.

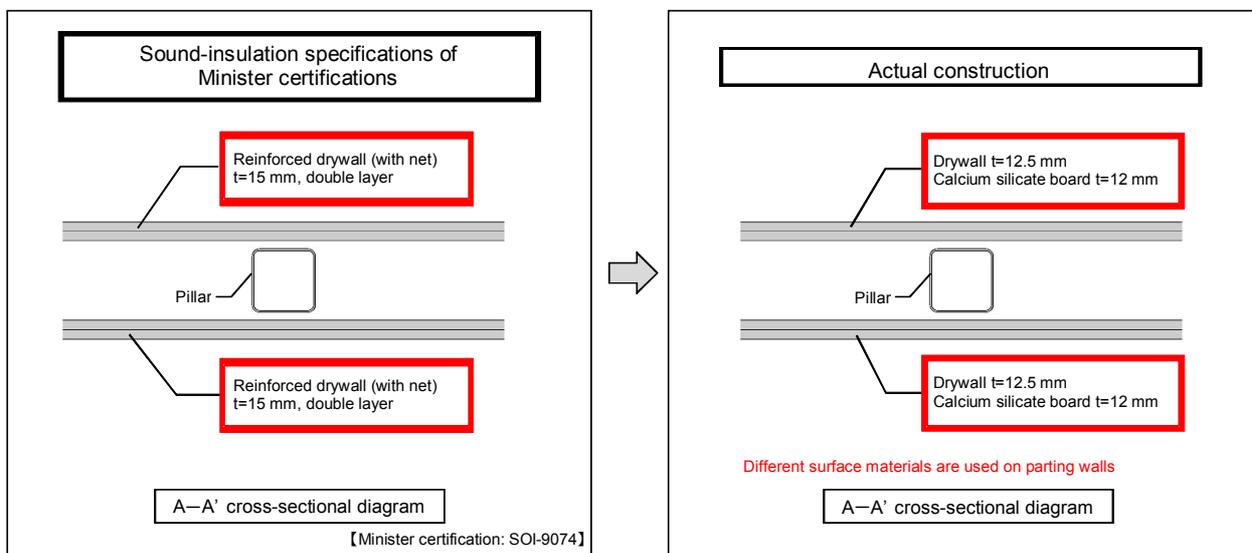
[Figure 2]

We confirmed 1 out of the 63 buildings do not meet one-hour semi-fire-resistant performance, as well as sound-insulation specifications certified by the Minister of Land, Infrastructure, and Transport, as noted in appendix 2.
