February 7, 2019

Company Name: **Leopalace21 Corporation**  
Representative: Eisei Miyama, President and CEO  
Code Number: 8848 (Tokyo Stock Exchange, First Section)  
Contact: Bunya Miyao, Director  
Tel: +81-50-2016-2907  
E-mail: [ir@leopalace21.com](mailto:ir@leopalace21.com)

**Progress Report of All-building Investigations and  
Notice Concerning Newly Confirmed Construction Defects**

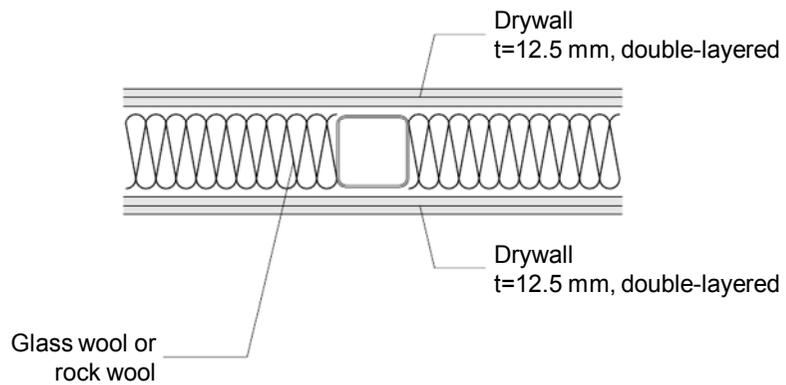
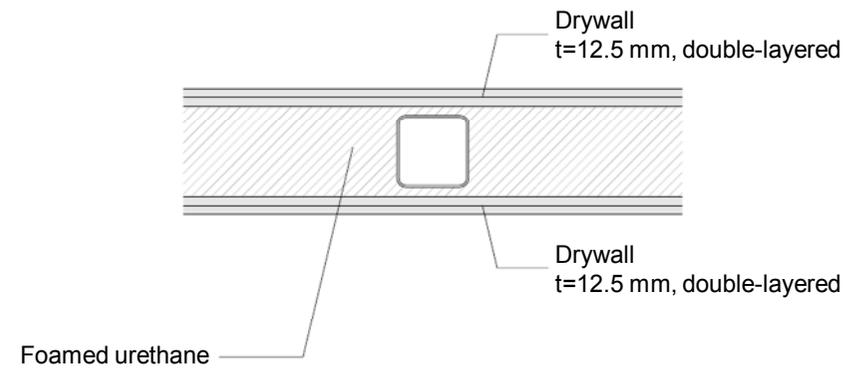
Appendix 2. Specifications of walls with foamed urethane (parting wall)

During the course of all-building investigations, we confirmed certain discrepancies in parting walls of Gold Residence and New Gold Residence series (both subject to top priority investigations, “GR” and “NGR”) constructed between June 12, 1996 and September 17, 2001. Discrepancies were confirmed in certain buildings constructed in 16 prefectures of Japan. Although it is written in construction certification documents that glass wool (fiberglass) is to be used as insulation material in parting walls, we confirmed that foamed urethane was used in certain buildings. There is a possibility that these buildings do not meet the sound insulation standards of apartments required by the Building Standard Law. “Foamed urethane was used” means that the installed wall panels (“subject panels”) were filled with foamed urethane. The foamed urethane was used as an insulation material.

At that time, the Ministry of Construction Notice No. 1827 (issued in 1970) required glass wool or rock wool to be used as insulation material in parting walls. However, since foamed urethane was recognized as a superior material in terms of insulation performance and price (foamed urethane is more expensive), we wrongly assumed that it met notice requirements.

Although fire resistance is ensured by double-layered gypsum boards (drywall), there is a possibility that sound insulation levels do not meet standards required by the Building Standard Law.

Currently, we are considering adding a layer from the inside of the room to repair ceilings and parting walls. We will consult with apartment owners and designated administrative agencies and decide the method and content of repairs.

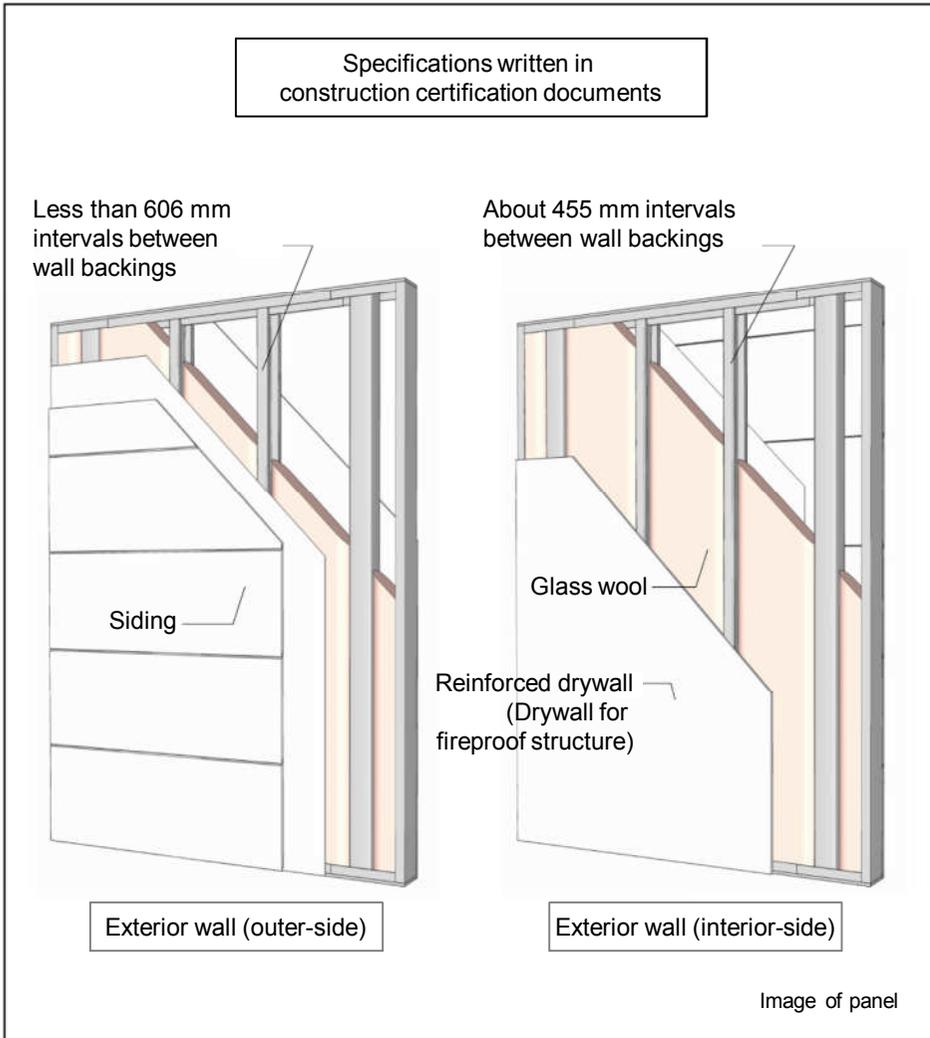
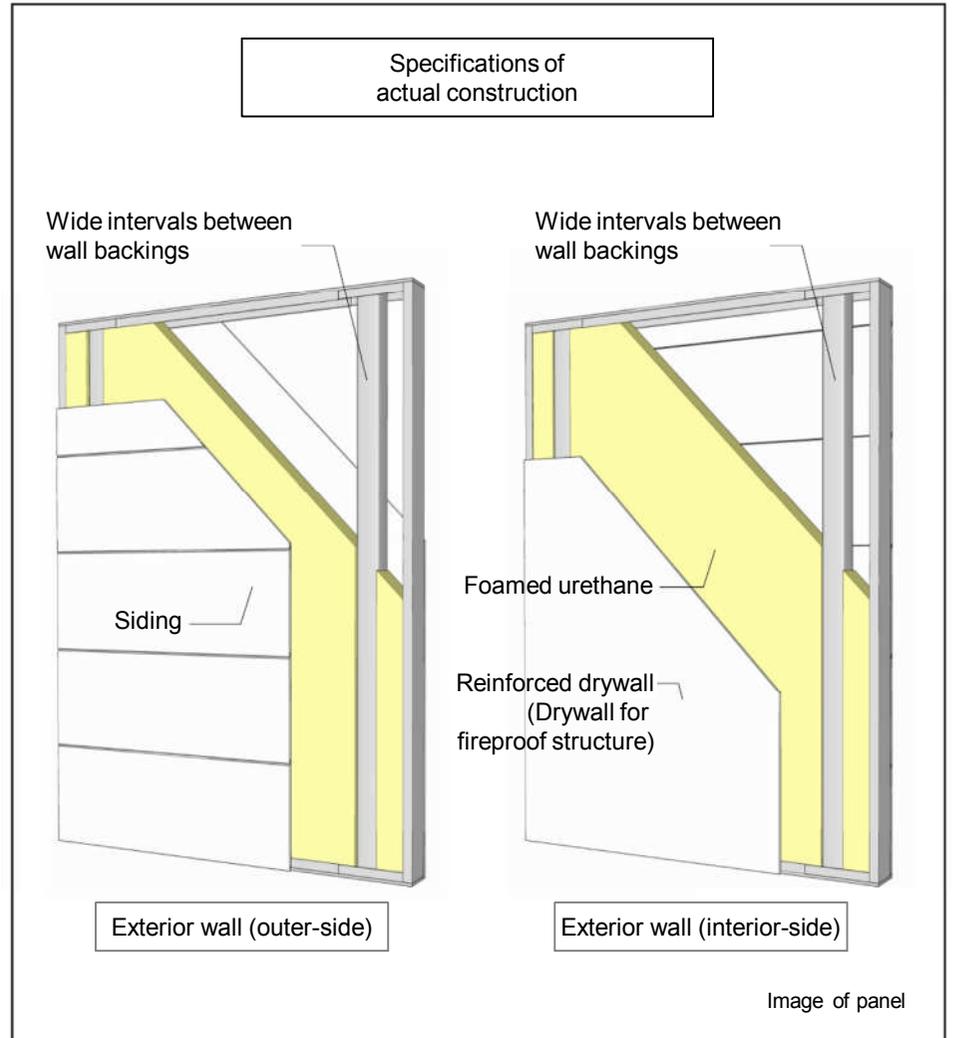
### Appendix 3. Specifications of walls with foamed urethane (exterior wall)

We confirmed that subject panels (noted in Appendix 3) were installed in exterior walls of “GR”, “NGR”, and Villa Alta (not subject to top priority investigations, “AGR”) series constructed in 16 prefectures between September 14, 1999 and February 9, 2001. According to the Building Standard Law, exterior walls of apartments require semi-fire-resistant or fireproof structures. However, we confirmed that certain buildings with the subject panels installed do not meet qualifications certified by the Minister of Land, Infrastructure and Transport<sup>\*1</sup>, as noted in construction certification documents.

The binding method of boards and the necessary length between wall backings is specified in qualifications certified by the Minister of Land, Infrastructure and Transport. However, we believe communication between the designing department and the product ordering department was insufficient, leading to the manufacturing of subject panels with specifications different from those specified in the qualifications.

At that time, we have conducted fire resistance performance tests, and received approval to a certain degree. However, since the buildings do not comply with qualifications certified by the Minister of Land, Infrastructure and Transport, we are considering repairs to match the specifications required by the qualifications.

For exterior walls, we are considering repairs to match qualifications certified by the Minister of Land, Infrastructure and Transport, and will consult with apartment owners and designated administrative agencies. At the same time, we will check whether or not we can acquire the qualifications.

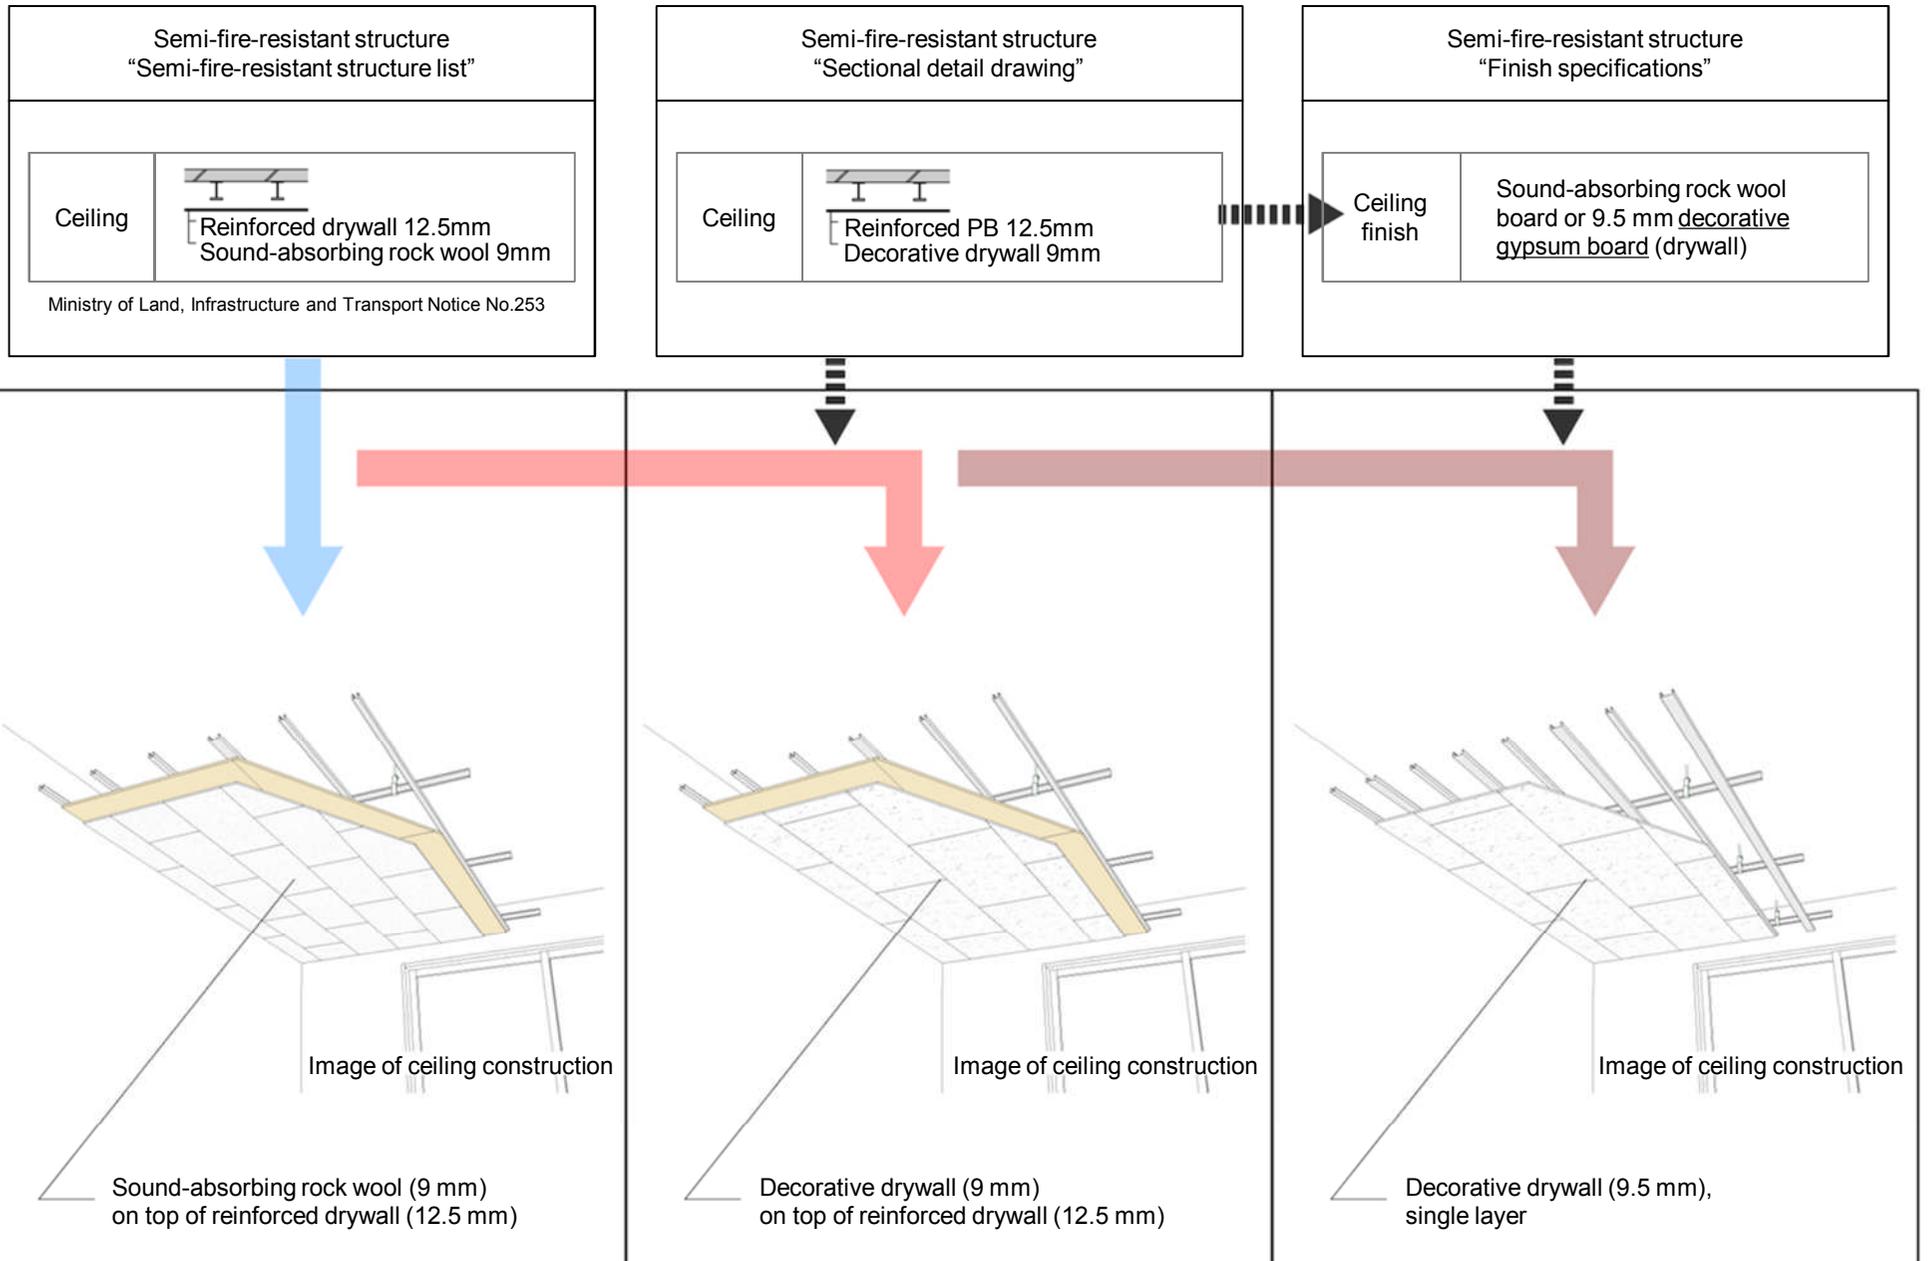
Appendix 4. Ceiling specifications of three-story Gold Residence with semi-fire-resistant structure

During the course of all-building investigations, we confirmed defects in ceilings (ie. living space floors) of “GR” series constructed between March 16, 1996 and January 22, 2001. Defects were confirmed in certain buildings constructed in 32 prefectures of Japan. According to the Building Standard Law, floors of three-story apartments require one-hour semi-fire-resistant structures, with double layers using materials specified in construction certification documents. However, we confirmed single-layered ceilings as well as double-layered ceilings with non-specified materials.

In the finish specifications included in construction certification documents, it is written that “semi-fire-resistant specifications are stated in the ‘semi-fire-resistant structure list.’” In the semi-fire-resistant structure list, it is written that the materials used for ceilings should be “12.5 mm reinforced gypsum board (drywall) + 9 mm sound-absorbing rock wool board.” However, in the sectional detail drawing, it is written that materials used for ceilings should be “12.5 mm reinforced PB + 9 mm decorative board (drywall).” In the finish specifications, it is written that materials for ceilings should be “sound-absorbing rock wool board or 9.5 mm decorative gypsum board (drywall).” We believe these inconsistent and misleading expressions have resulted in misunderstandings, thus leading to construction defects. In addition, the decorative board and the sound-absorbing rock wool board are similar in appearance, and it is also not clear from the outside whether there is one layer or two layers after the ceiling is finished. Due to these factors, it is highly probable that construction supervision failed to indicate any inadequacies. Therefore, we believe that inadequate use of decorative boards on ceilings was not corrected and constructions were carried out.

Fire resistance of apartments with defects does not meet standards required by the Building Standard Law. Therefore, we will promptly make arrangements for relocation.
