Company Name: **Leopalace21 Corporation**
Representative: Eisei Miyama, President and CEO
Code Number: 8848 (Tokyo Stock Exchange, First Section)
Contact: Bunya Miyao, Director
Tel: +81-50-2016-2907
E-mail: ir@leopalace21.com

**Notice Regarding Non-compliance with Specifications Approved
Based on Building Standards Act**

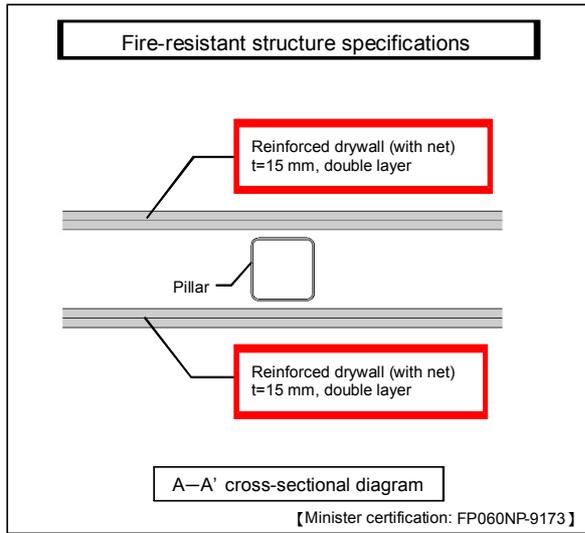
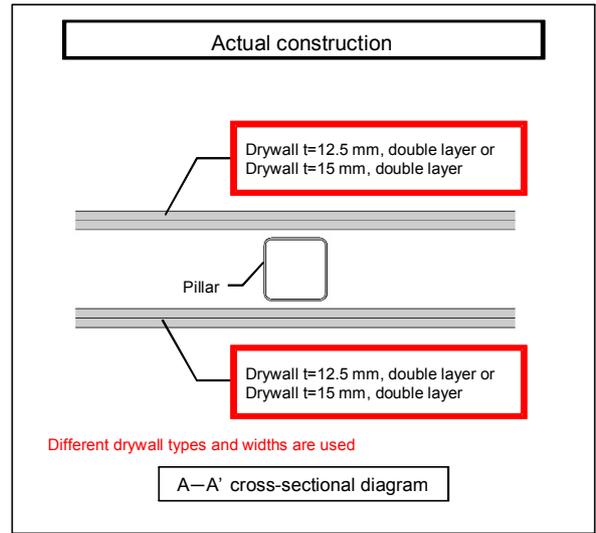
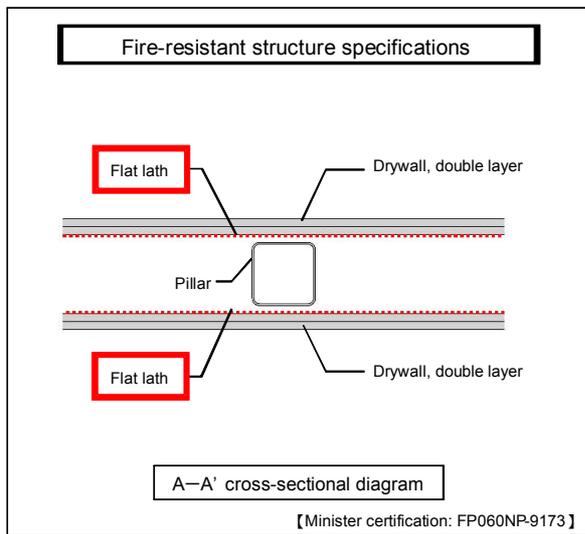
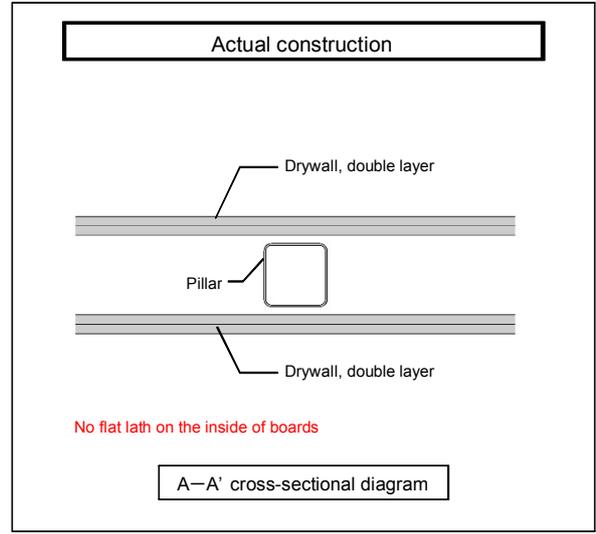
Appendix 1

During the course of all-building investigations, non-compliance with the specifications approved based on of the Building Standards Act was identified in the investigation carried out on February 25, 2019 with the owner present. As a result of further investigation, the Company confirmed that there is a possibility that certain properties do not comply with specifications certified by the Minister of Land, Infrastructure, and Transport (Fire-resistant structure: FP060NP-9173 and FP060NP-9371, sound-insulation: SOI-9074) provided in the construction design documents as shown in the attached appendix 1, despite the requirement for parting walls to be fireproof under Articles 27 and 61 of the Building Standards Act (hereinafter “subject defects”).

Position of parting wall

Concerning subject defects, the Company will report to specific administrative agencies as soon as possible and discuss corrective measures. Based on discussions, the Company will determine repair methods and take progressive steps to ensure compliance with laws and regulations.
