February 7, 2019

Company Name: **Leopalace21 Corporation**  
Representative: Eisei Miyama, President and CEO  
Code Number: 8848 (Tokyo Stock Exchange, First Section)  
Contact: Bunya Miyao, Director  
Tel: +81-50-2016-2907  
E-mail: [ir@leopalace21.com](mailto:ir@leopalace21.com)

**Progress Report of All-building Investigations and  
Notice Concerning Newly Confirmed Construction Defects**

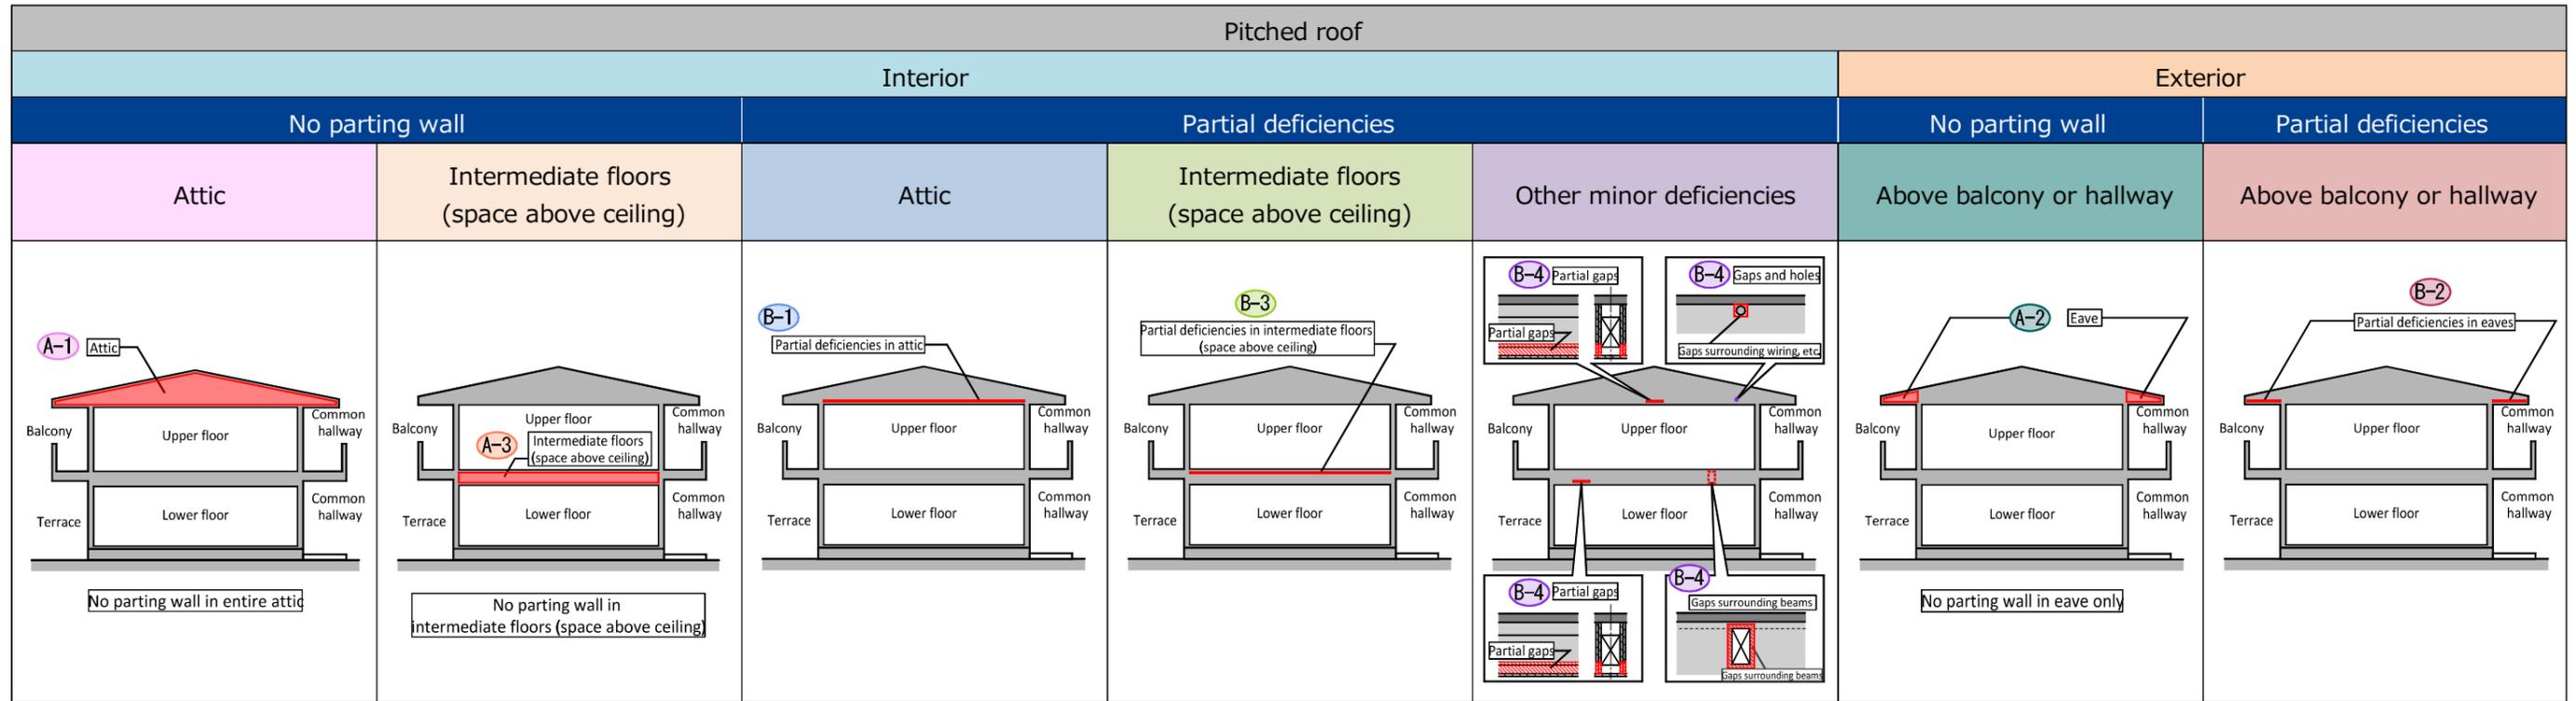
Interior					Exterior	
					No parting wall		Partial deficiencies			No parting wall	Partial deficiencies
					Attic	Intermediate floors (space above ceiling)	Attic	Intermediate floors (space above ceiling)	Other minor deficiencies	Above balcony or hallway	Above balcony or hallway
					A-1	A-3	B-1	B-3	B-4	A-2	B-2
<b>Top priority investigations</b>											
Subject to investigations	Total to be investigated	Investigation commenced	Investigation progress rate	No deficiencies							
Nail series	913	904	99.01%	6	824	0	20	0	33	0	21

Interior					Exterior	
					No parting wall		Partial deficiencies			No parting wall	Partial deficiencies
					Attic	Intermediate floors (space above ceiling)	Attic	Intermediate floors (space above ceiling)	Other minor deficiencies	Above balcony or hallway	Above balcony or hallway
					A-1	A-3	B-1	B-3	B-4	A-2	B-2
<b>Top priority investigations</b>											
Subject to investigations	Total to be investigated	Investigation commenced	Investigation progress rate	No deficiencies							
6 series	14,370	13,067	90.93%	1,745	412	636	1,900	535	5,067	516	649

\*The disclosure method has been changed to reflect prioritization of judgments concerning interior deficiencies.  
 \*Above are preliminary figures, and are subject to changes or revisions.
